POND No. 4 DAM

ROCHESTER AND PITTSBURGH COAL COMPANY

PHASE I INSPECTION REPORT
NATIONAL DAM INSPECTION PROGRAM

POND NO. 4 DAM
INDIANA COUNTY, COMMONWEALTH OF PENNSYLVANIA
NDI No. PA 00851
PENN DER No. 32-81

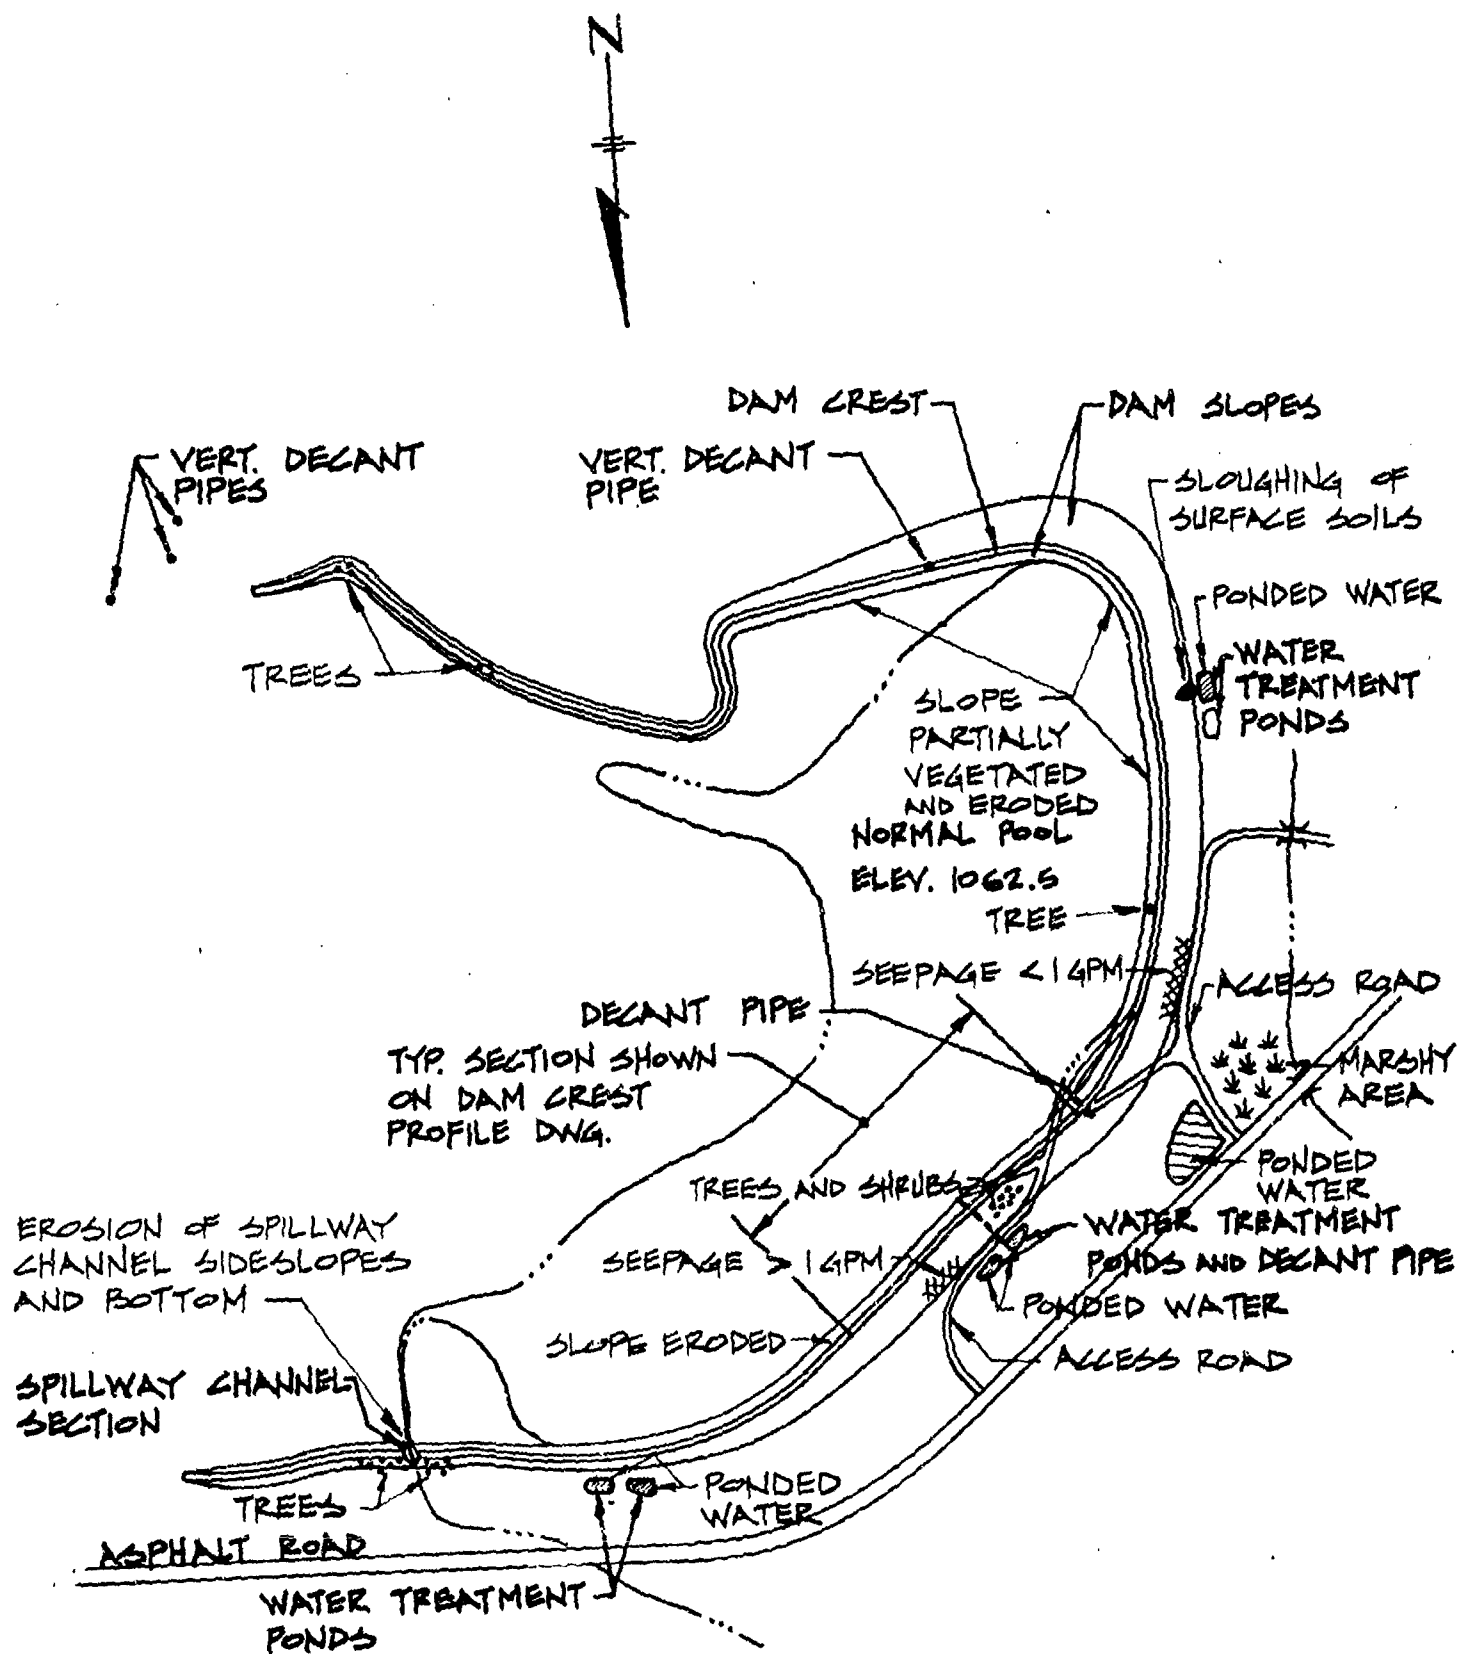
FIELD SKETCH
POND No. 4 DAM

2. Seepage: Seepage zones were observed along the downstream embankment toe at the locations shown on the Field Sketch. The seepage zones were generally small in surface area and had estimated flow rates of about 1 gpm. There was no visible evidence of erosion channels or movement of soil fines at either discharge. However, the dense vegetation cover may have obscured the presence of soil fines or erosion. A notable increase in vegetation cover and growth was also observed at these areas and along the embankment toe.

1. Outlet Works: Four 6 inch diameter vertical decant pipes were observed at the locations shown on the Field Sketch. All vertical decant pipes were partially or fully clogged and buried within 2 to 3 feet of the capped top end section. None of the existing vertical decant pipes appeared functional. Refer to Photograph No. 6.

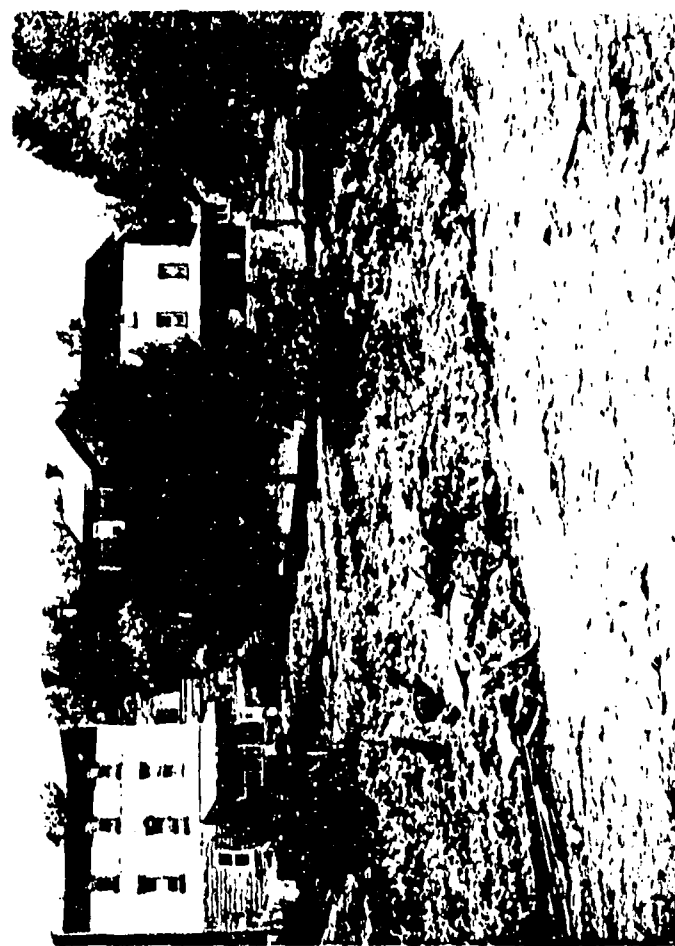
6

- B. OUTLET WORKS: The vertical decant pipes appeared clogged and are not believed functional. These drain pipes are therefore considered to be in poor condition. The horizontal decant pipes were observed free of flow obstructions and structural distress, and are assessed in good condition.
- C. SPILLWAY CHANNEL SECTION: Although the existing spillway channel section is in fair condition, the potential exists for severe erosion of the unprotected sideslopes and channel bottom. Riprap of adequate size and weight should be provided.
- D. HAZARD POTENTIAL: Based on observations of downstream conditions, Pond No. 4 Dam was assigned a "significant" hazard potential rating.

2. Outlet Works: The vertical decant pipes appeared clogged, are not believed functional, and are assessed in poor condition. The horizontal decant drain pipes were observed free of flow obstructions and are considered to be in good condition.
